## Condition Report - Toilets on A22

The community surveyors were asked to assess the condition of toilets due to ongoing problems

**Date:** Tuesday 17<sup>th</sup> May 2022

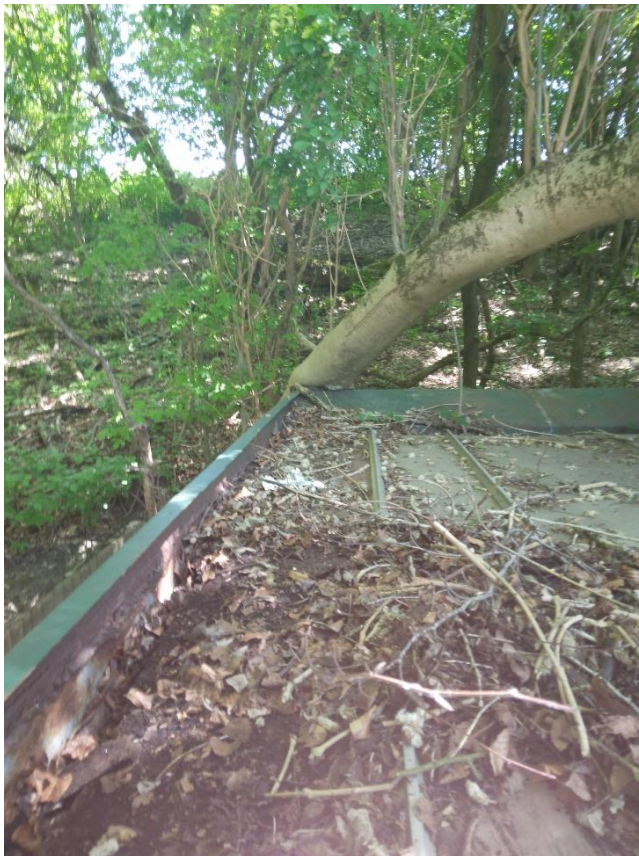
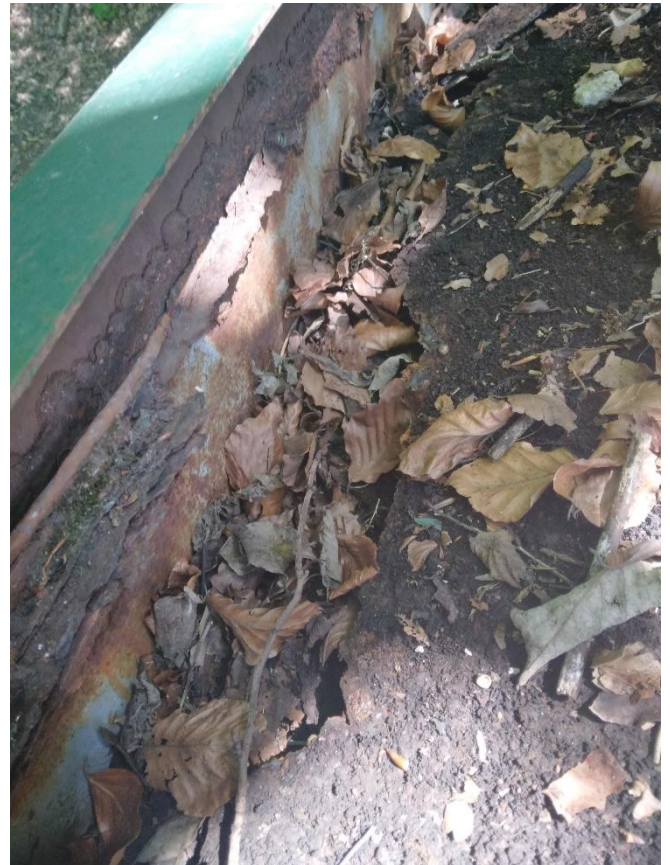
Due to the proximity to trees it would appear an outlet has been blocked in the past and caused water to sit in the integral gutter causing this to corrode and break

**Item 1** – The roof has corroded and is no longer watertight. The tree is growing around the structure exerting force onto the building.

Due to the unsafe structure no one is currently maintaining the leaves falling down, which is exacerbating the situation. There are a number of locations you can see rust around the outside of the roof structure, which need attention.

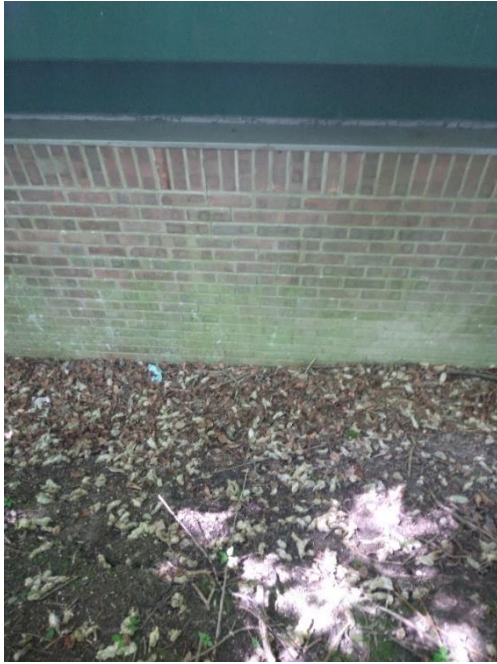
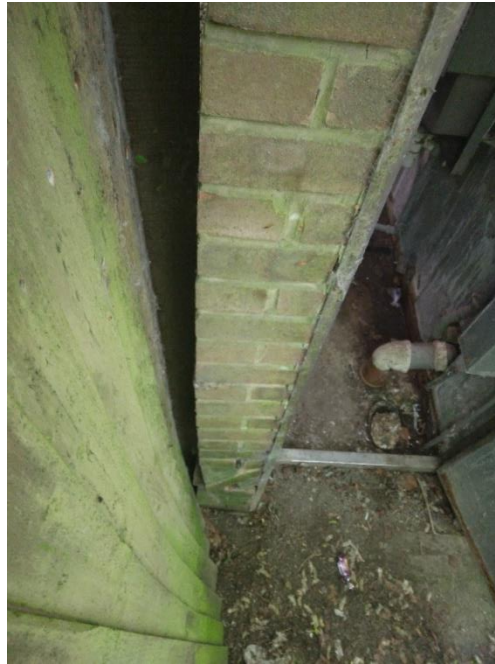
**Walls** – The walls are brick; the internals are clad in stainless steel. At the rear of the building down the middle there appears cracking, partially due to the proximity of the tree roots.

**Item 2** – At the rear of the building, there is a crack running down the middle. In the bottom right-hand corner, the brickwork is distorting at the bottom and top.

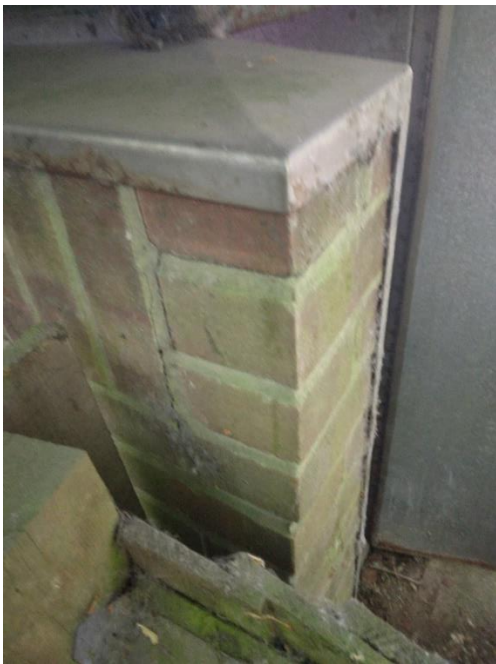
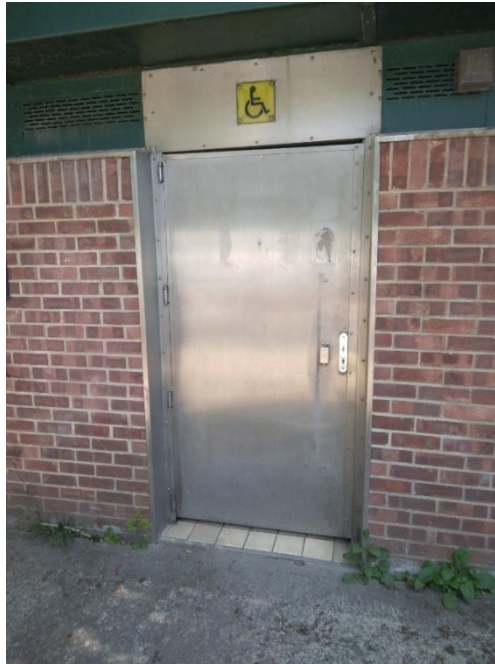
**Item 3** – The brickwork is also distorting at the top and the door no longer closes in this corner. Also, you can see the gaps at the tops of the door, how uneven the building is.

A structural engineer has not assessed the property as far as we are aware but due to the proximity of the tree/s this is not helping the building and its foundations. Due to the cladding, it is not possible to assess the internal condition of the brickwork.
